Tech Notes

"OLE JIM" GALLAUDET COLLEGE Washington, D.C.

NUMBER 1

Proper Painting And Surface Preparation

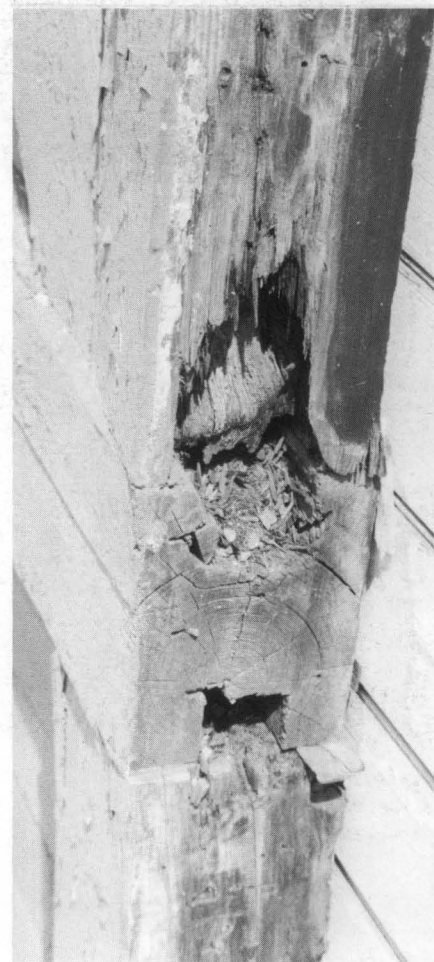
Figure 5. Some internal core deterioration was masked by sound surface wood. Water entering the connection of the post and beam framing rotted out the mortise and tenon pockets. These areas were consolidated and filled with epoxy. Photo: Baird Smith, AIA

Wood Deterioration The architect determined that prior to repainting, the deteriorated wood would have to be replaced or consolidated in order to provide a sound painting surface. While surface deterioration was readily evident in areas, further investigation revealed the rotting of the timbers at the tenon pockets (see figure 5).

The deterioration of the timber joints was from long-term decay probably dating back to the turn of the century. Fortunately, the surfaces of the structural timbers were in good condition; the rotted tenon pockets in the structural members could be consolidated and filled with epoxy resins rather than be replaced. About 10% of these timber joints were in need of such repair.

When wood was consolidated and filled with epoxy resins, the strength of the epoxy fill was formulated to match the strength of the wood as closely as possible. The major areas of deterioration were mortise and tenon pockets of the vertical and horizontal structural members. With the surface wood of these members in generally good condition, only the punky areas of the beam or post had to be dug out. The remaining shell forming the tenon pocket was consolidated as a precaution to stop any future deterioration. The hollow was filled with epoxy resins

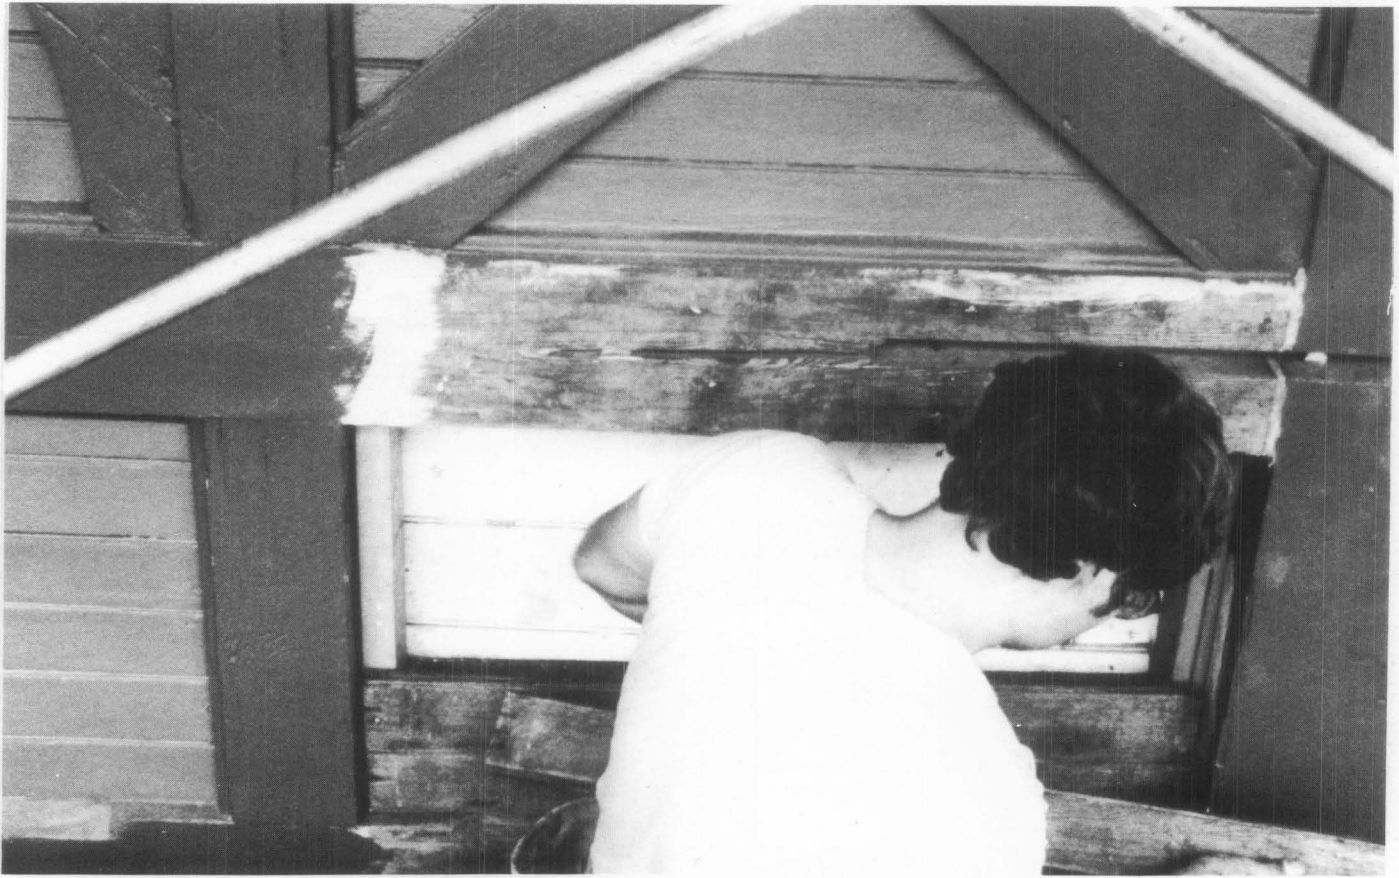
Figure 6. Sound pieces of wood salvaged from elsewhere on the building are being used to replace this deteriorated tongue and groove panel. In most cases, deteriorated wood trim, sills, and paneling were replaced with redwood that was back primed. Photo: Bryan Blundell

Repair or replacement of damaged wood was the next step. This phase involved epoxy consolidation and epoxy infill of damaged structural members and the selective replacement of moderately deteriorated trim and sills. When wood was replaced, primed redwood was used since today's yellow pine is less durable than the heartwood yellow pine originally used on the building. Approximately 20% of the applied decorative trim (diagonals and ogee boards) were replaced along with five panels of tongue and groove paneling (see figure 6). Good sections salvaged from the wood panels were reused for small repairs elsewhere on the building.

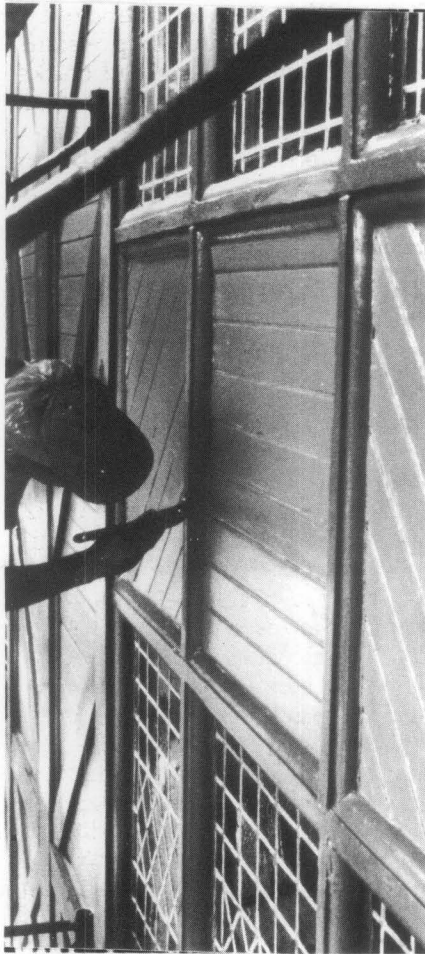
Figure 9. The building was painted with two coats of oil-alkyd primer and two top coats of acrylic latex. Photo: Bryan Blundell

Acrylic latex paint, with its good color stability, was selected for the two top coats primarily for its durability and "breathability" (see figure 9). Compatible with the manufacturer's oil-alkyd primer, the acrylic latex also has flexibility of movement. This is an important quality since wood naturally expands and contracts.

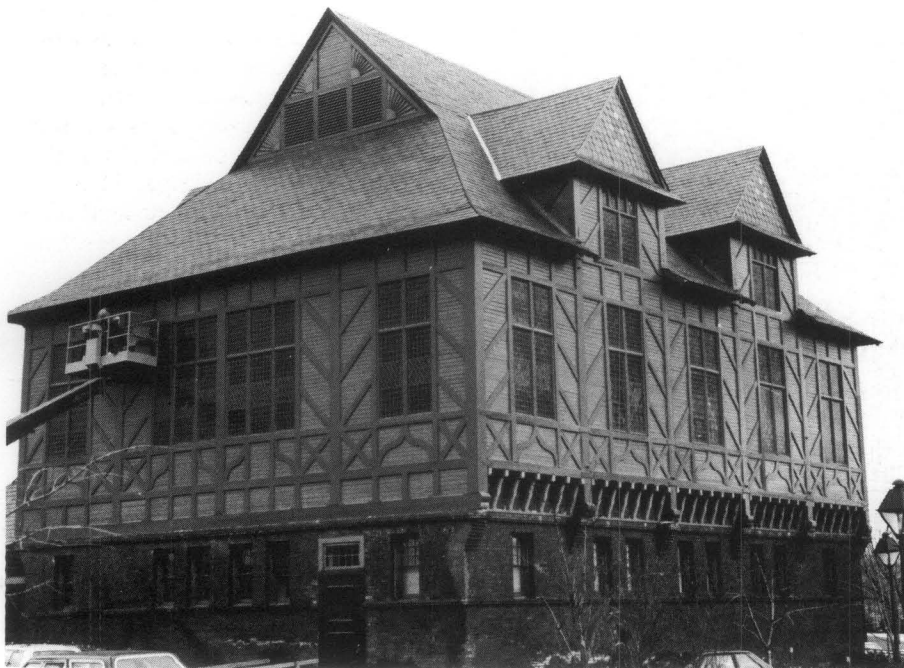
Figure 10. The college will inspect the building on a regular basis to ensure that any problems are immediately corrected. Photo: Charles Fisher

For "Ole Jim," a 7-year life is expected from the new paint job before repainting will be necessary. Under normal conditions, 7 years is the commonly recognized life span for paint applied to bare wood which has been properly prepared. Future repainting should be much easier and cheaper due to the addition of trim pieces and thorough caulking to eliminate pockets where water collected. The owner is committed to regular inspection of the building and the correction of any problems as soon as they are apparent (see figure 10).
